THESIS FOR THE DEGREE OF LICENTIATE OF ENGINEERING

Moisture Conditions in Exterior Wooden Walls and Timber During Production and Use

Department of Civil and Environmental Engineering
Division of Building Technology
CHALMERS UNIVERSITY OF TECHNOLOGY
Gothenburg, Sweden 2014

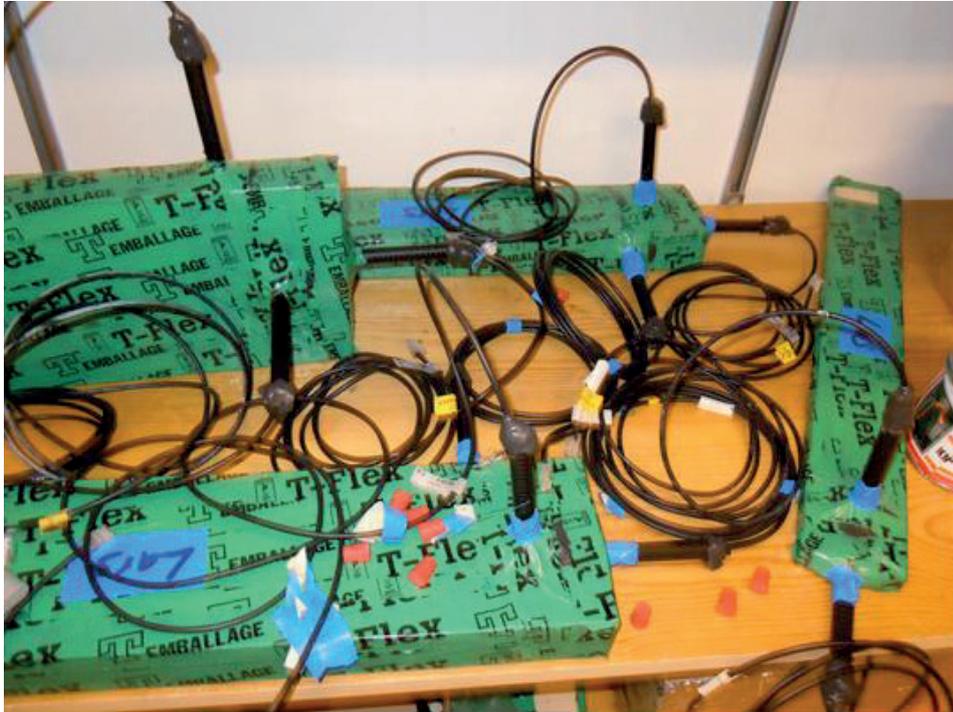
Figure 7. Sealed specimens with measuring tubes, 12 mm inner diameter, assembled on surfaces and in the centre as well as an installed RH sensor.

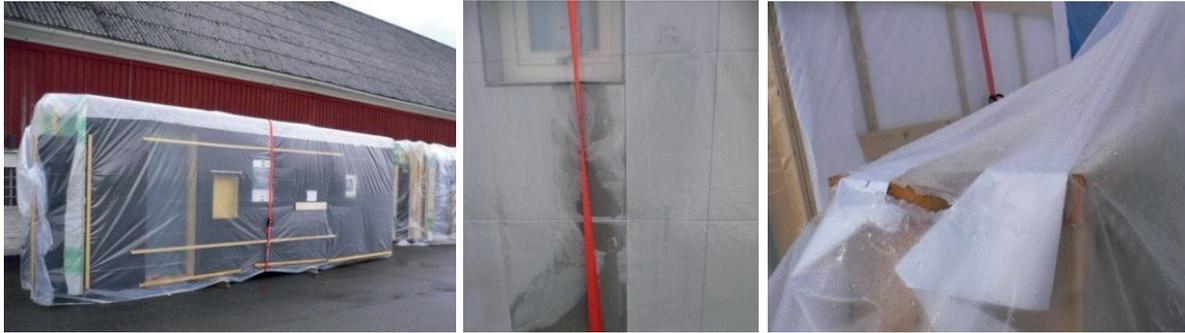
Figure 18. Observations from outdoor storage of wall elements. One of the house manufacturers stored completed wall elements outdoors in the factory area for several weeks, see (a). They were wrapped in plastic, although parts were found that were not wrapped. In some cases, the plastic was torn in several places, see (c). As a result, some parts of the elements were extremely wet behind the plastic, see (b), while others had microbial growth on them.

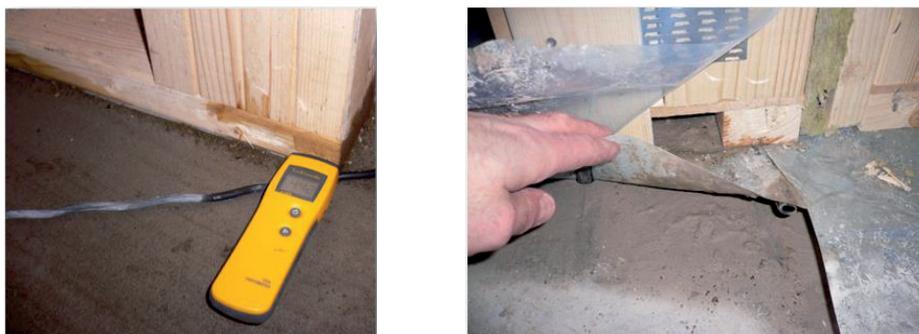
Figure 20. Observations from erection stage.

Wet sills or plates were found in six buildings in interior and exterior walls, as shown in Figure 19a-b and Figure 20. These sills also have microbiological growth. If it was raining while buildings were being erected at the site, there was no way the sills would not get wet. In several cases (from all manufacturers) the sills were found to be still wet several weeks after the building had been erected. There is a need for changes to design and production methods. Hansson (1989) made the same recommendation around 25 years ago.

Selected test exposure is based on field experience (Olsson et al. 2011a). The sill designs were placed in a shallow water bath, containing a water depth of 1-2 mm of distilled water for one (sill design 1, 5) or three (sill design 2, 3, 6, 7) days (see sill design 3 and 4 in Figure 21). The wooden sill, sill design 4, is placed on 50 mm XPS, create level difference, whereby water absorption is prevented. Assembling the prefabricated timber-frame detached house generally takes one to two days, and requires the use of a crane. After the wall elements and roof trusses have been lifted into position and secured, the underlay of the roof can usually be applied within three days of starting to erect the structure. The concrete foundation slab will usually have been prepared by mounting both the installation sill and moisture proof membrane under the sill a day or two before the elements or house are delivered and mounted. The connection between the bottom edge of both interior and exterior wall, sill, installation sill and the concrete slab are usually exposed to rain water that often collects on the concrete slab (see Figure 19 and Figure 20).

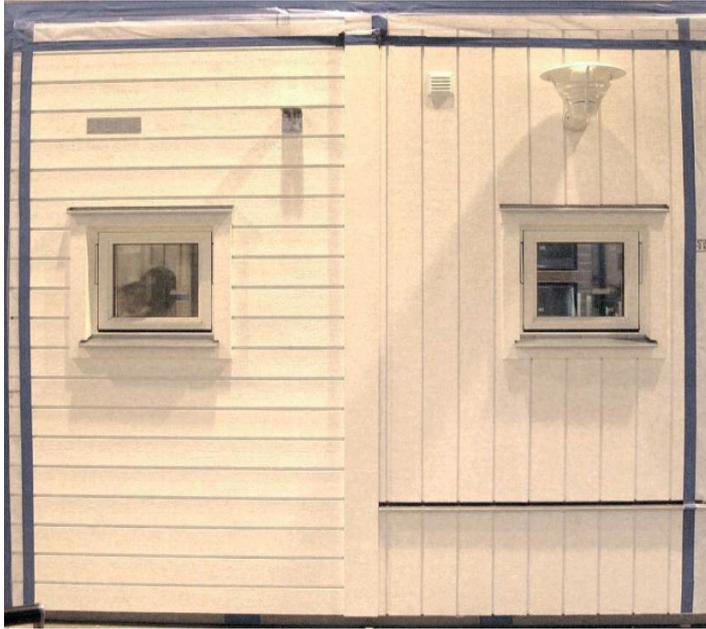
Figure 28. The two test items, manufacturer A, with horizontal and vertical wood panelling respectively.

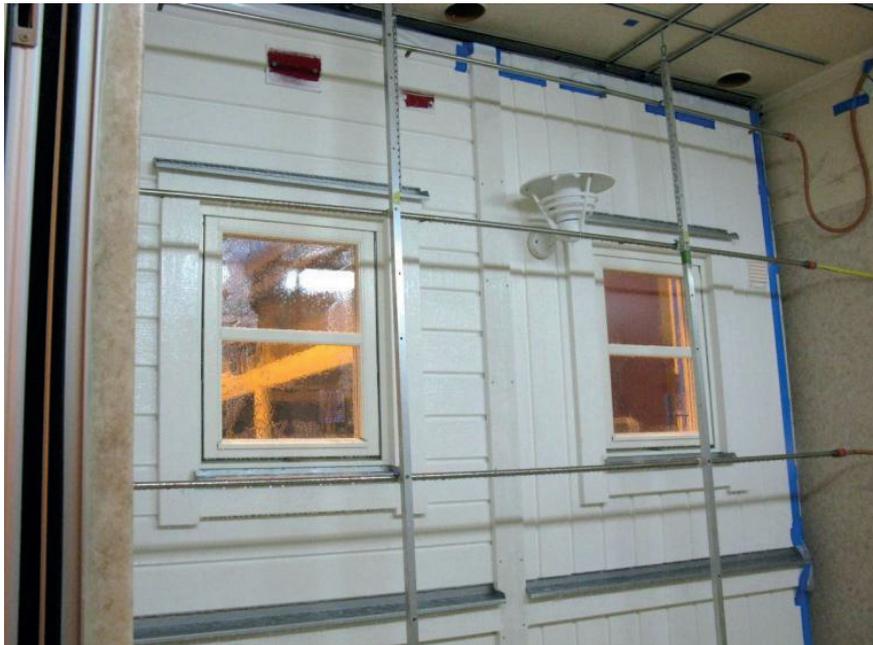
Figure 29. Ongoing testing of two test items, manufacturer B, with horizontal and vertical wood panelling respectively in the rain chamber.

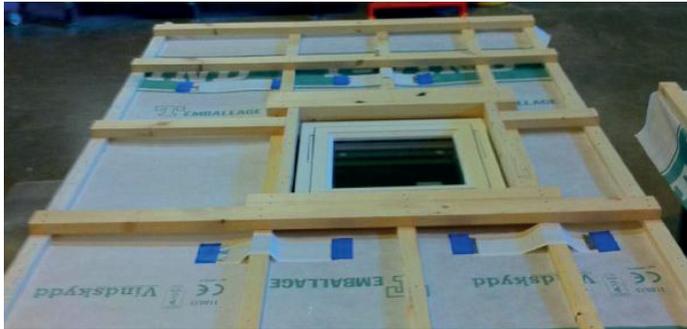
Figure 30. Indicators were positioned just below all details in the ventilation gap and behind the façade; test item A with vertical façade panel.

for 60 minutes for each step 0-150 Pa, 0-300, 0-450 and 0-600 Pa. The moisture indicators were checked after each pressure level; indicators consisted of absorption paper and thin electrodes for resistance measurement (see Figure 30 and Figure 31). At the end, the wall was opened in order to investigate any further leakage.

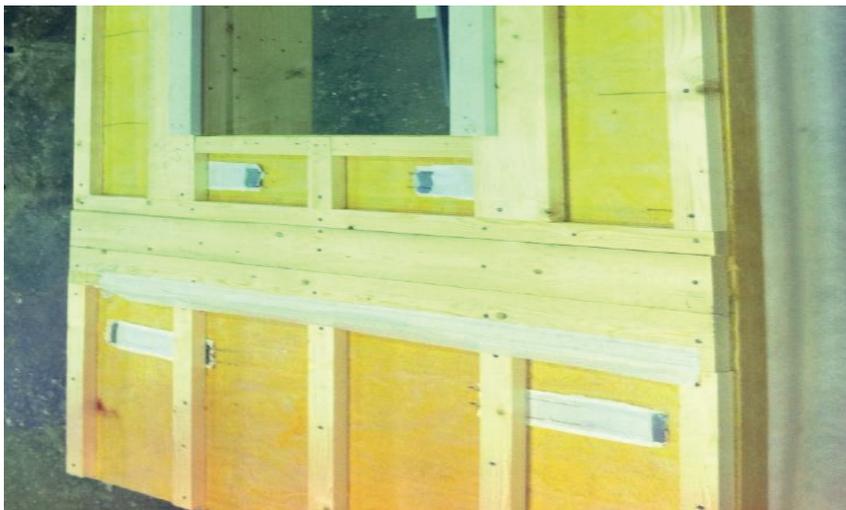
Figure 31. Indicators were positioned just below all details in the air gap and behind the façade; test item B with horizontal façade panel.

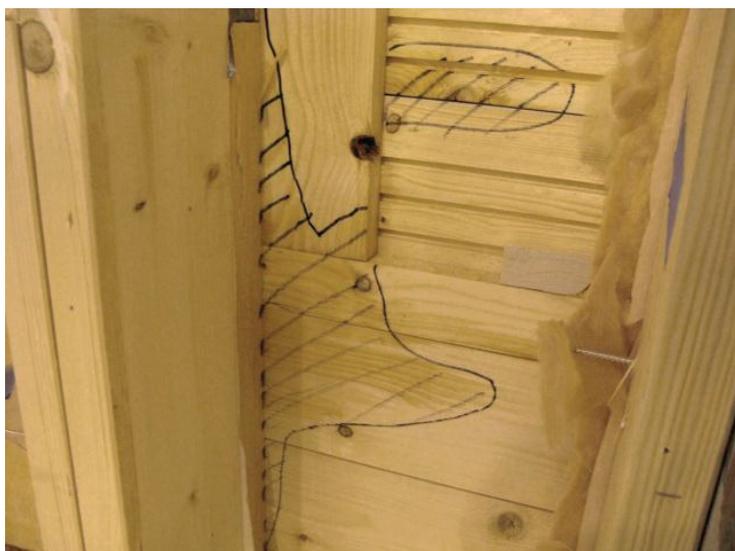
Figure 32. Photo of the back of the wooden façade panel (test item B) after the wall was opened from the inside. Highlighted areas indicate wet areas behind the façade/horizontal panel, battens and underlay board for the horizontal metal plate.

Connections, penetrations and joints in wood façades may increase the risk of leakage, at least into the ventilation gap, despite the fact that, in principle, the ventilation gap acts to equalise pressures on each side. Much of the inwardly leaking water was absorbed by the rear panel, laths, battens etc (see Figure 32). On the whole,

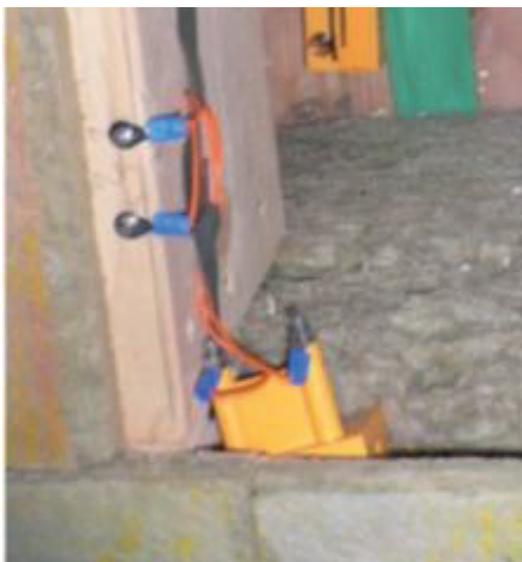
Figure 46. The image shows placement of sensor 16 (RH and temperature) and extension cables for MC bolted onto the outside of the stud.

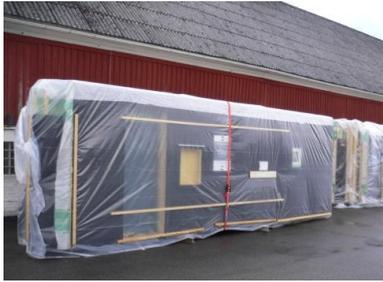
FIG 7.

FIG 7, 8 and 9 show observations from outdoor storage of wall elements wrapped in plastic. One of the house manufacturers stored completed wall elements outdoors in the factory area for several weeks. They were wrapped in plastic, although parts were found that were not wrapped. In some cases, the plastic was torn in several places. As a result, some parts of the elements were extremely wet, while others had microbial growth on them.

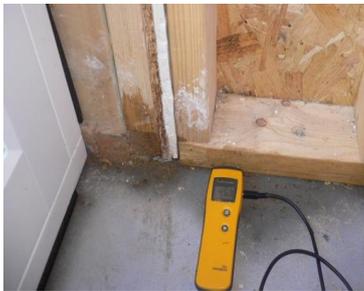
FIG 10.

Wet sills were found in six objects in interior and exterior walls, as shown in FIG 10 and 11. These sills had also microbiological growth. FIG 12 shows the exterior of an outer wall, with poor joints in wind barrier/protection board and gaps around windows. If it was raining while buildings were being erected at site, the sills were unavoidably wet. In several cases (from all manufacturers) the sills were found still wet for several weeks after the building had been erected. Exterior wall designs from all three manufacturers were found in which the sill was visible diagonally from below or from the outside. One of the manufacturers supplied a roof underlay consisting only of impregnated plywood, which was assessed as not being resistant to direct rain. Microbial growth was also found on the underside of this roof. The wind barrier was exposed to rain in six of the objects over longer periods of time, despite having leaking joints and connections. See, for example, FIG 12. Dirt was found on timber and parts of the structure in five objects, while roof leaks in store buildings were found at two manufacturers' premises.

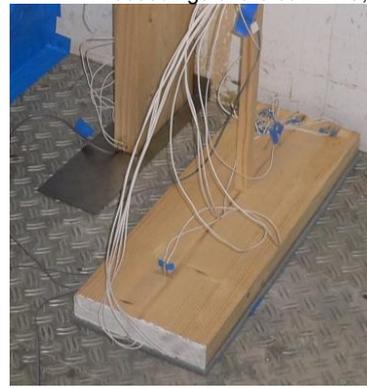
Fig. 7.

Figure 7 shows the sill design 6 (45 x 220 mm wooden sill) and sill design 7 (45 x 220 mm wooden stud) in the outdoor part of the climate chamber. Figure 8 shows the position of the relative humidity sensors in the moisture barrier before installing the sill (Section 6).

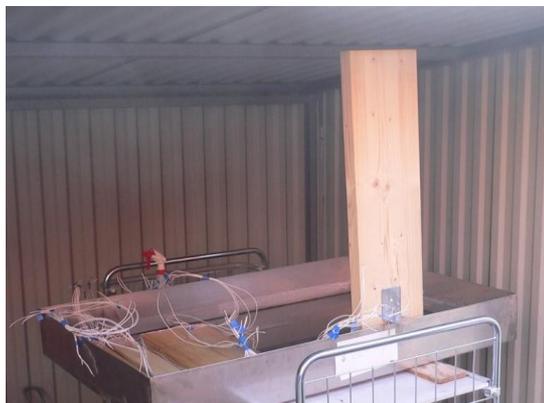
Fig. 9. Sills and vertical stud in the water bath (1–2 mm depth), outdoors under a roof.

The sill designs were placed in a shallow water bath, containing a water depth of 1–2 mm of distilled water, and exposed outdoors under a roof for one or three days, starting on 2 August 2010 (see Figure 9). Twice a day (morning and evening) for two days, the fitting sills in designs 2, 3 and 6 were exposed to rain for about one minute (simulated by water spraying) for an equivalent of 0.3 mm of rain per application. The ends of the vertical studs (Sections 5 and 7) were also placed in water baths, but not exposed to rain. The horizontal stud in Section 4 was exposed to only about two minutes of water bath, followed by air drying for one day.

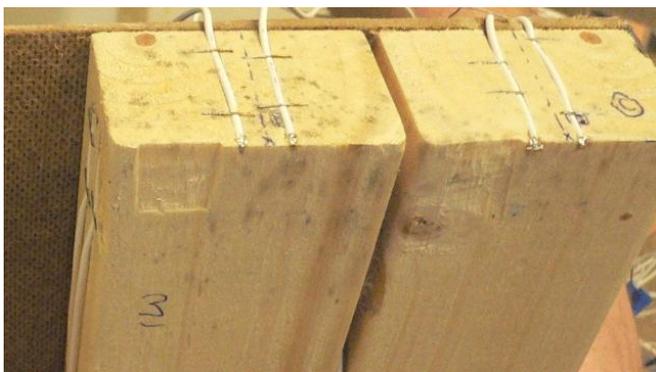
Fig. 20. Visible mould growth on the underside and end of the sill.

Proceedings of the 5th IBPC, Kyoto, Japan, May 28-31, 2012 was found at test positions e, f, and g, where the relative humidity had exceeded 95% for at least two weeks. Visible mould growth could be seen at a few test positions, as shown in Figure 20, but in most cases with substantial growth there was nothing to be seen by the naked eye. No musty smell could be detected from any of the material samples.

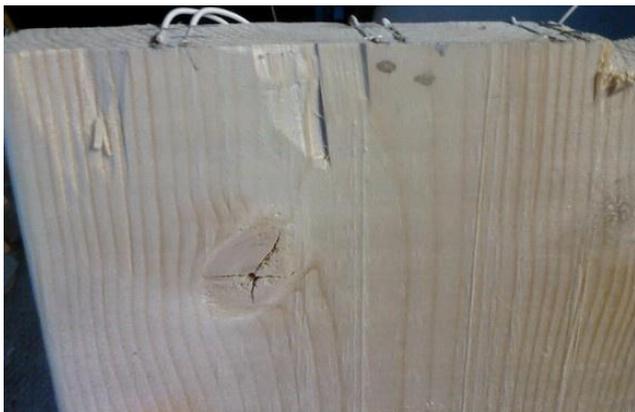
Fig. 23. No visible mould growth on the underside of the sill at the end of the sill. Microbial analysis showed extensive growth.

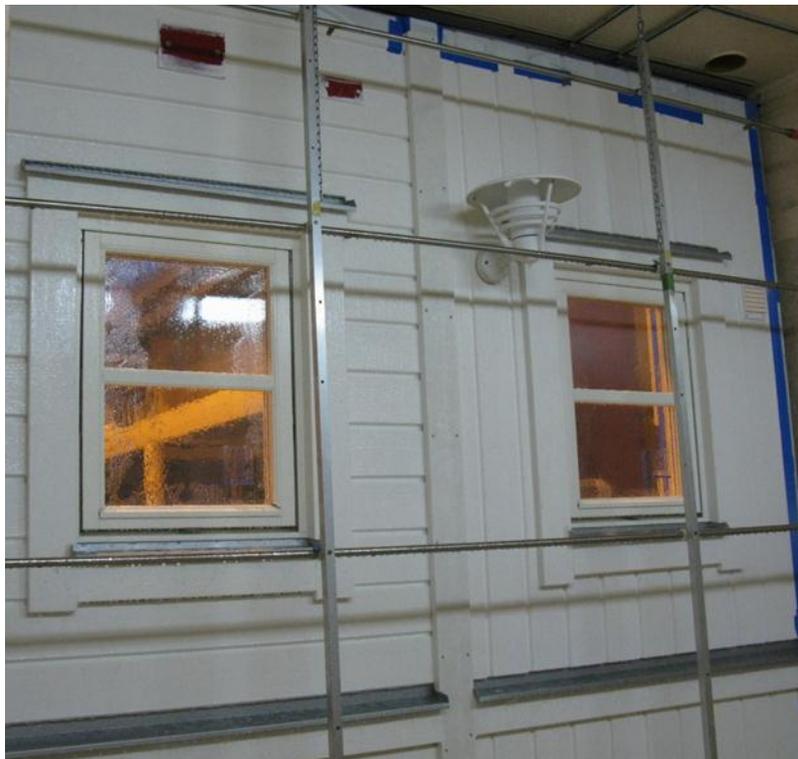
Pågående slagregnsprovning av träfasad med detaljanslutningar

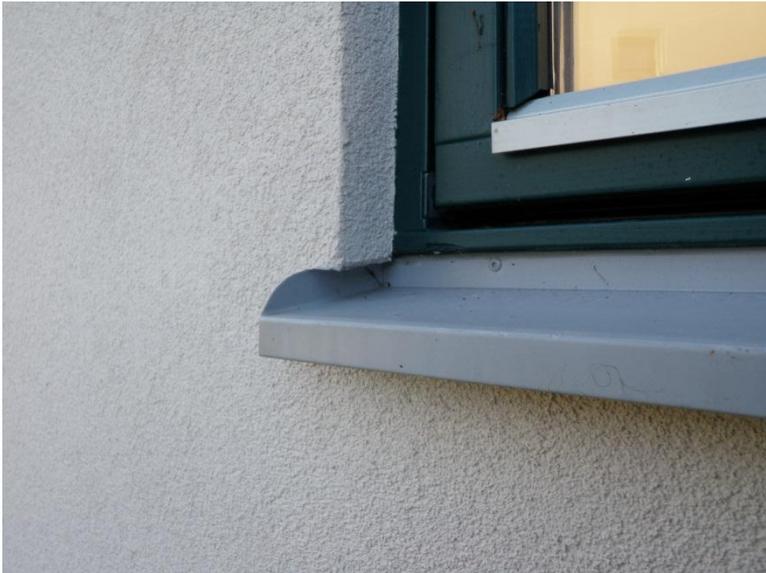
En putsad regelvägg med ett fönster

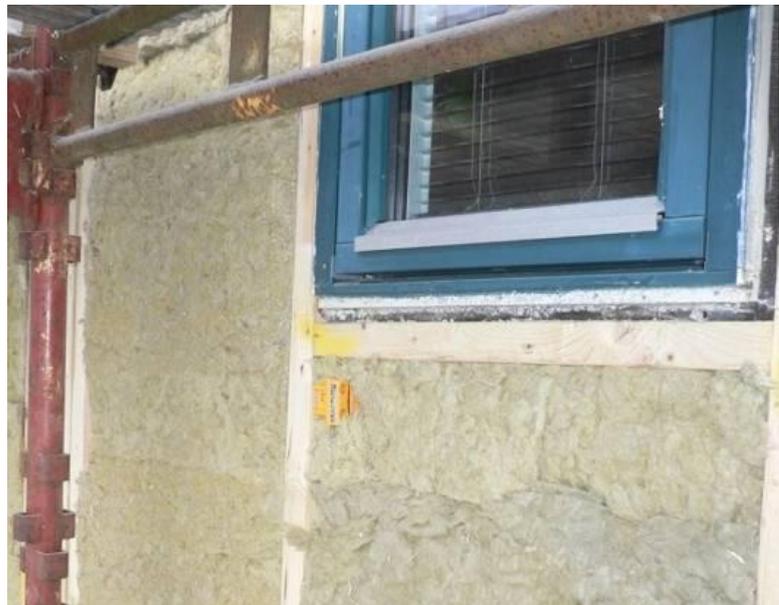
En avklädd regelyttervägg och placering av en fukt- och temperaturgivare alldeles under ett fönster.
