Estimation of Rock Quality in Road Projects from Pre-Study to Aggregate

A comparison of the Los Angeles-coefficient for rock cores and
base course

*Master of Science Thesis in the Master's Programme Infrastructure and
Environmental Engineering*

MASTER'S THESIS 2014:38

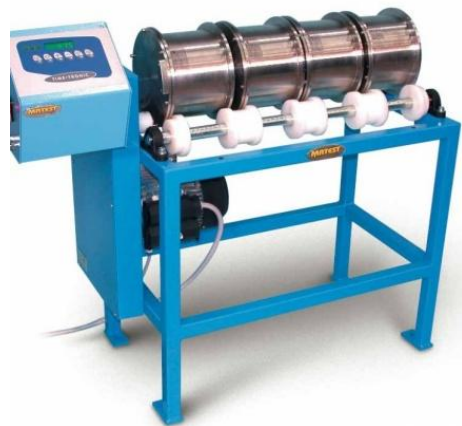
Figure 2.3 The Micro-Deval testing machine with four cylinders (Jet Materials, 2014).

The Micro-Deval method was developed in France in the 1960s to determine the resistance to wear (Stenlid, 2000). It was introduced in ATB VÄG in 2004 and the standard for the testing procedure is referred to as SS-EN 1097-1 (Viman & Broms, 2005). The testing equipment consists of a cylinder, steel balls (5kg), water (2,5kg) and the rock sample (500g). A Micro-Deval machine can be seen in Figure 2.3.

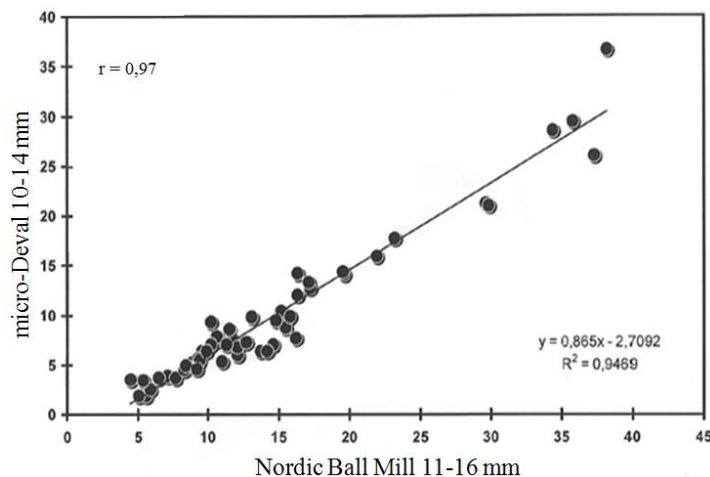
Figure 2.4 Relationship between Micro-Deval and Nordic ball mill tests (Stenlid, 2000).

The Nordic method is similar to the Micro-Deval method but is only used for tests on aggregates in wearing courses (Viman & Broms, 2005). However, the relationship between Nordic ball mill tests and Micro-Deval tests is strong and a correlation coefficient of 0.97 can be obtained, see Figure 2.4 (Stenlid, 2000).

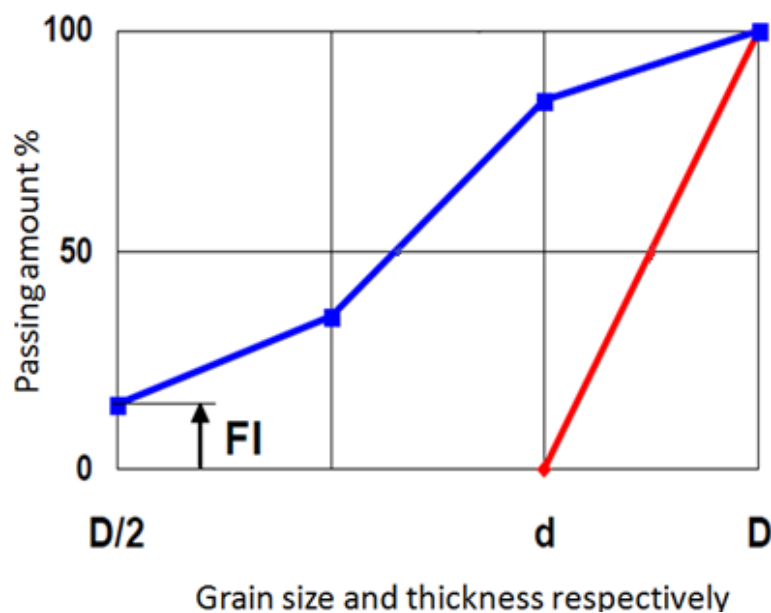
Figure 2.5 Definition of flakiness index, FI. The red line represents the grain sizes with square mesh and the blue line represents the thickness of the grains with grid sieving, modified (Viman & Broms, 2005).

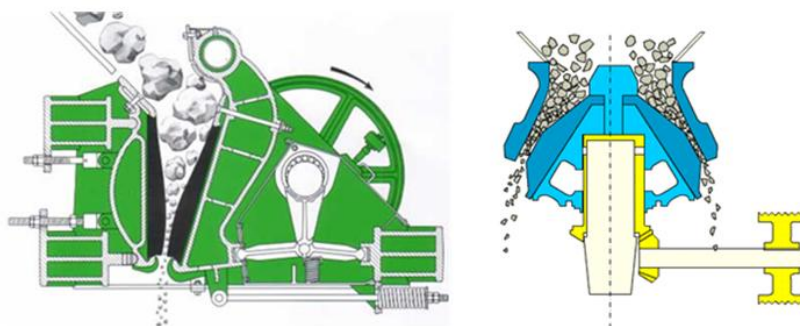
Figure 2.8 Jaw crusher to the left and cone crusher to the right (Pennsylvania Crusher, 2014; Aggregate Design Corporation, 2014).

There are mainly two kinds of crushers present in the quarry and laboratory environment⁵; jaw crusher and cone crusher. The difference between the crushers is according to Evertsson⁶ that the jaw crusher causes cracks between the points of contact and an unfavourable grain shape while the cone crusher crushes aggregates “stone against stone” and creates smoother edges. Schematic images of a jaw crusher and a cone crusher can be seen in Figure 2.8.

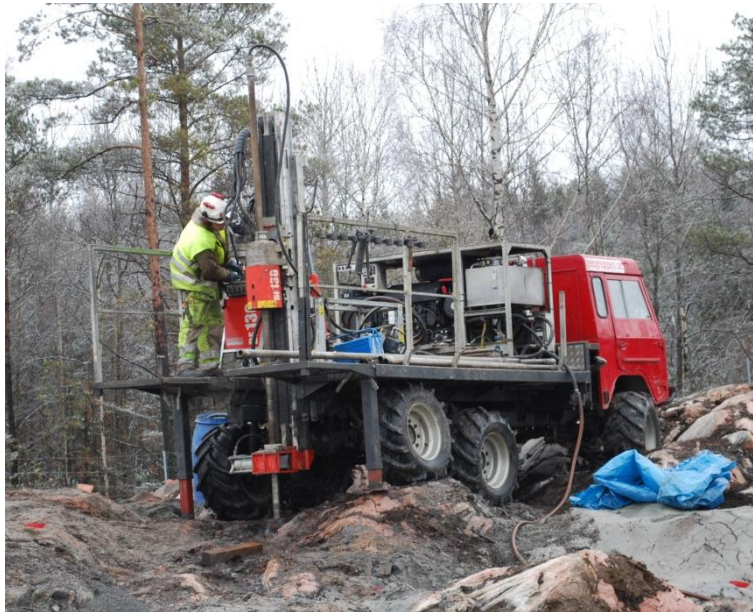
Figure 4.2 The core drilling machine that performed the drilling at all locations.

The core drilling was performed by GEO-gruppen AB. The drilling equipment consisted of a Longyear, BQTK with a core diameter of 40,7 mm. The cores were drilled from the top of the bench. To avoid potential damages due to previous blasts, the cores were drilled at a minimum distance of 10 meters from the face of the bench. To cover the variations in geology, the cores were drilled as evenly distributed over the bench as the equipment could reach. The core drilling machine was attached to an off-road vehicle, see Figure 4.2.

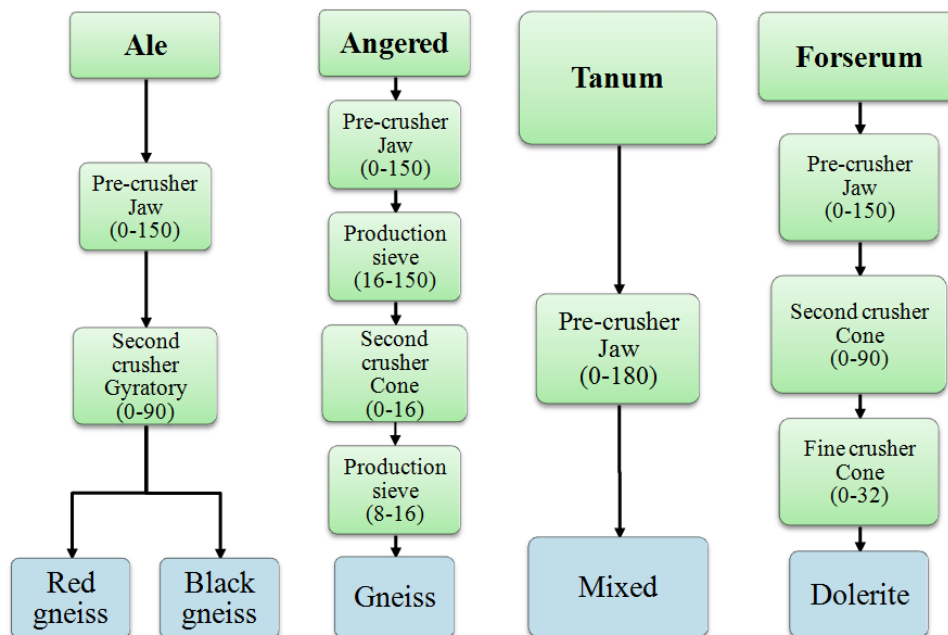
Figure 4.3 Flowchart for preparation of samples of base course.

In Figure 4.3, the crushing steps to create samples of base course can be seen in a flowchart. Five different rock types of base course were tested; red and black gneiss from Ale, gneiss from Angered, mixed rock from Tanum and dolerite from Forserum. All samples were collected from flattened piles of aggregates in the fractions presented in Figure 4.3.

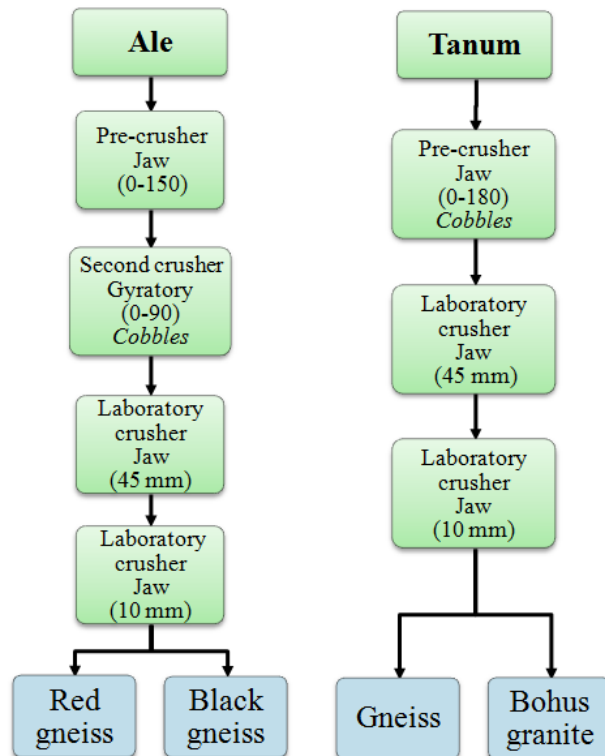
Figure 4.4 Flowchart for preparation of cobble samples.

Cobbles were abstracted from the 0-150 mm pile in Tanum after the pre-crusher. The cobbles from Ale were abstracted from the 0-90 mm pile after the second crushing step to create the cobble samples. In Figure 4.4, a flowchart showing the crushing steps to create the cobble samples can be seen. The cobble samples were additionally crushed in the laboratory. Four rock types of cobbles were tested, red and black gneiss from Ale and gneiss and Bohus granite from Tanum.

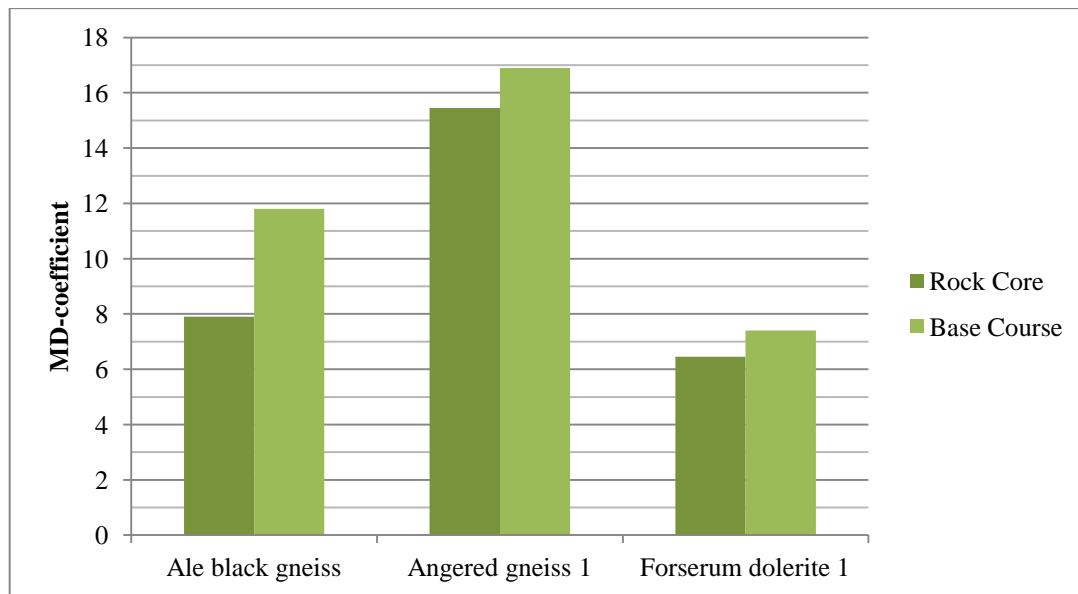
Figure 5.2 Comparison between MD-coefficient for rock core and base course.

The result from the Micro-Deval tests is shown in Figure 5.2. The MD-coefficient for rock core is better than base course for all locations. In Appendix F, all values from the LA-tests and MD-tests are presented in a table.

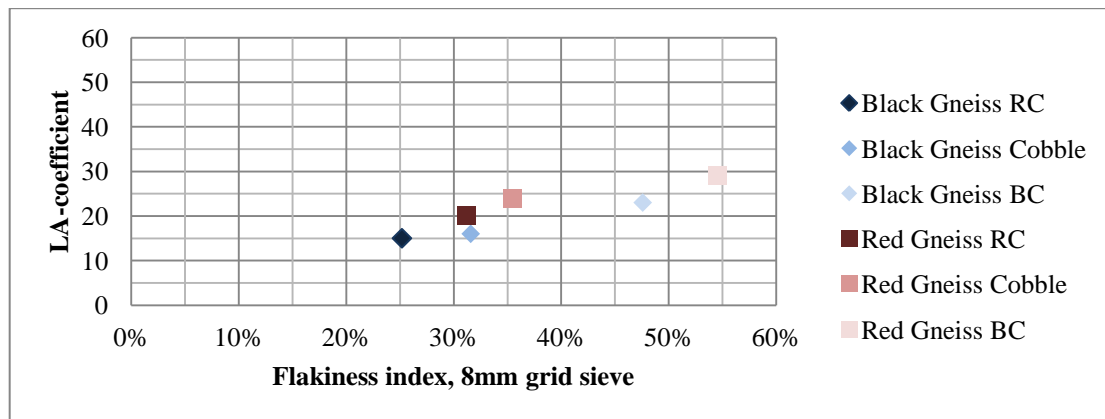
Figure 6.4 Relation between LA-coefficient and flakiness index (8 mm grid sieve) for Ale.

It is obvious from studying Figure 6.4 that the tendencies seen in Figure 6.1-6.3 apply for the different rock types and sample methods in Ale. A higher flakiness index will lead to a higher LA-coefficient. The same trend applies for both Tanum and Forserum and can be seen in Appendix H. In Appendix H the same plots for the other grid sieves can be seen as well. The other grid sieves indicates the same trends as for Figure 6.4. However, the trend is not applicable for Angered as shown in Figure 6.5.

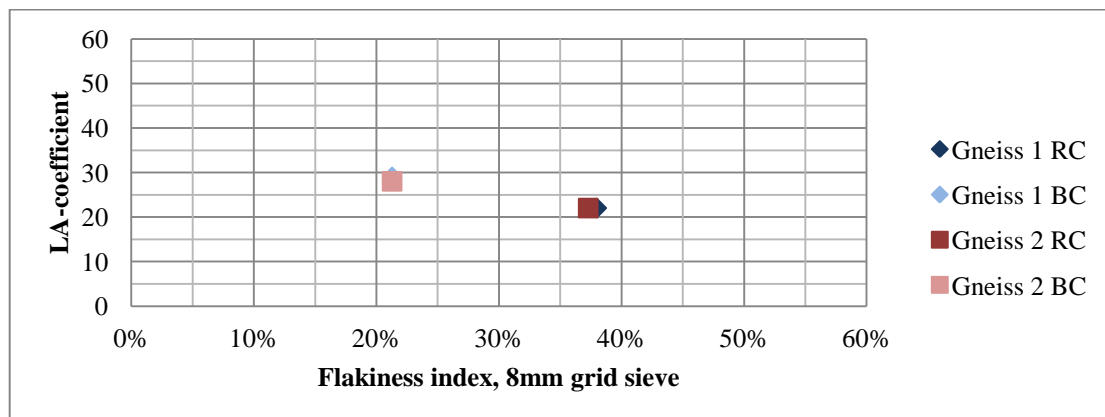
Figure 6.5 Relation between LA-coefficient and flakiness index (8 mm grid sieve) for Angered.

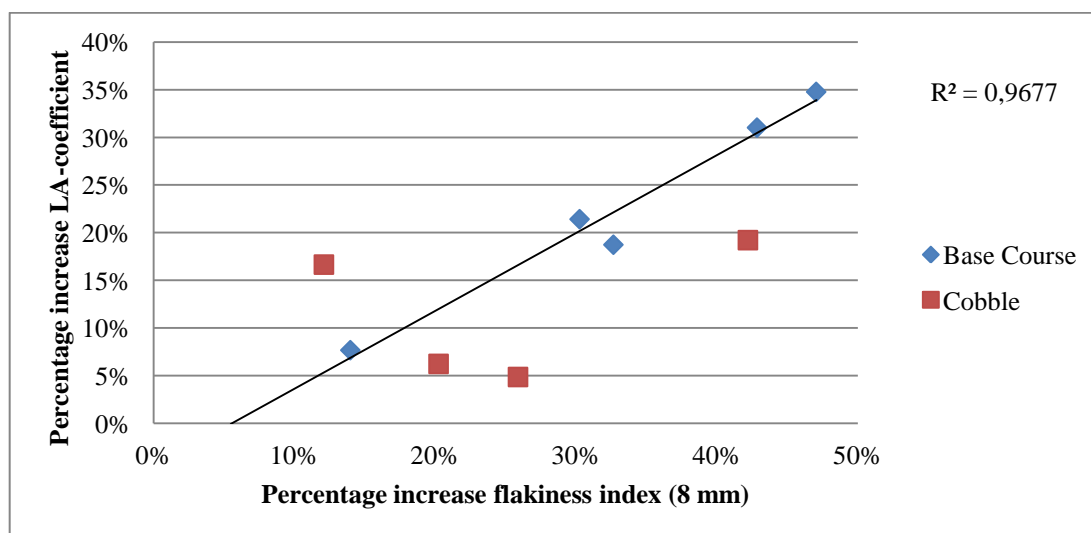
Figure 6.6 Relation between the percentage increase of the LA-coefficient and flakiness index (8 mm grid sieve) from rock core to base course and cobble, respectively.

The result of the calculations from Equation (8) and Equation (9) are presented in a table in Appendix I. The results are also plotted in Figure 6.6, except for the values for Angered that are neglected in this analysis since the flakiness index is higher for rock core than base course.

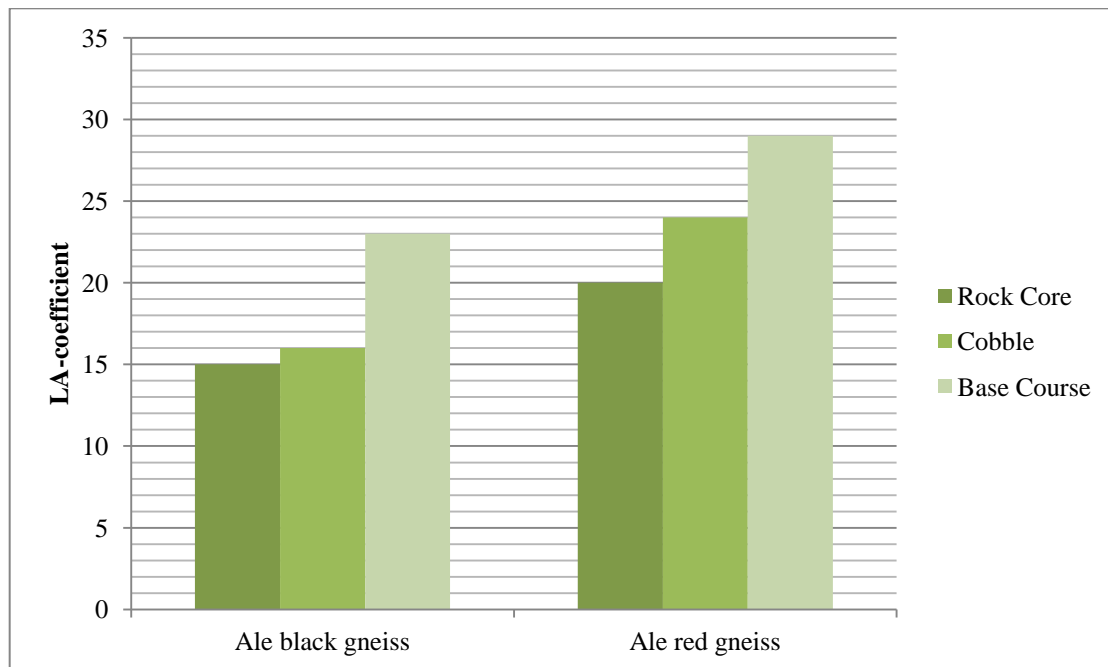
Figure 6.7 Comparison of LA-coefficient for rock core, cobbles and base course for Ale.

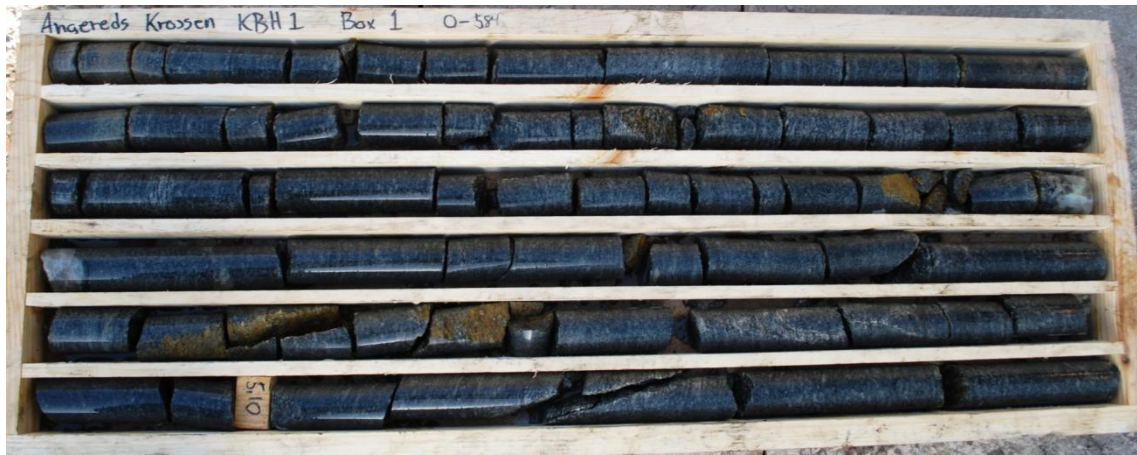
Figure B.1 Angered KBH1 Box 1 [0.0–5.84 m]

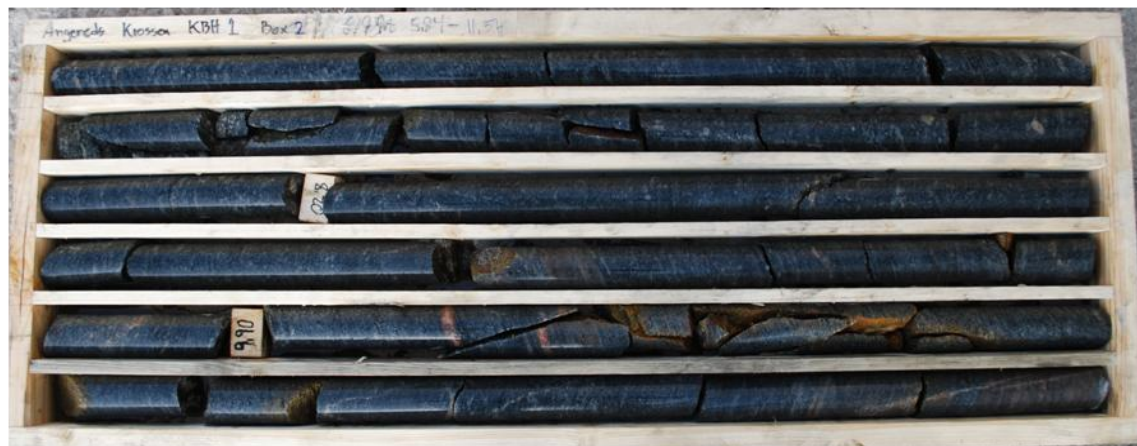
Figure B.2 Angered KBH1 Box 2 [5.84–11.54 m]

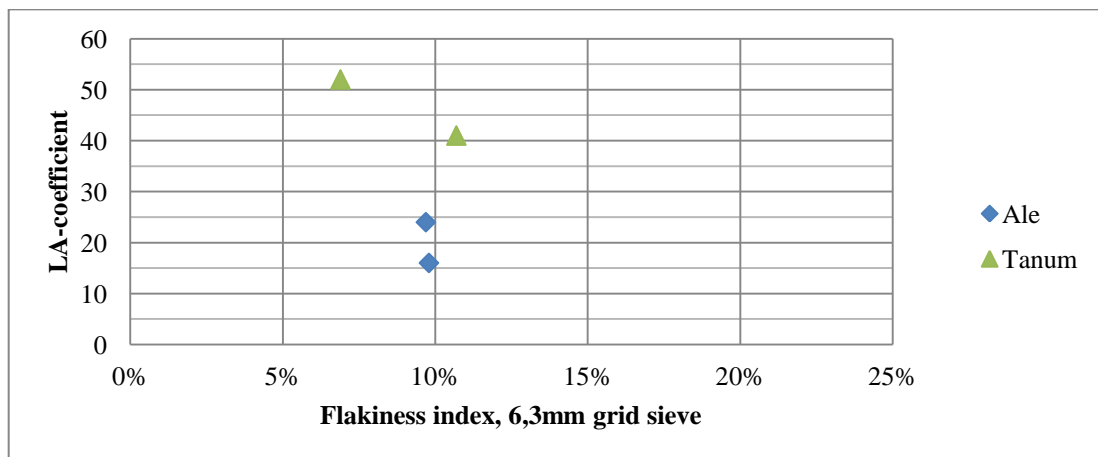
Figure G.2 Relation between LA-coefficient and flakiness index (6,3 mm grid sieve) for cobbles at all locations.

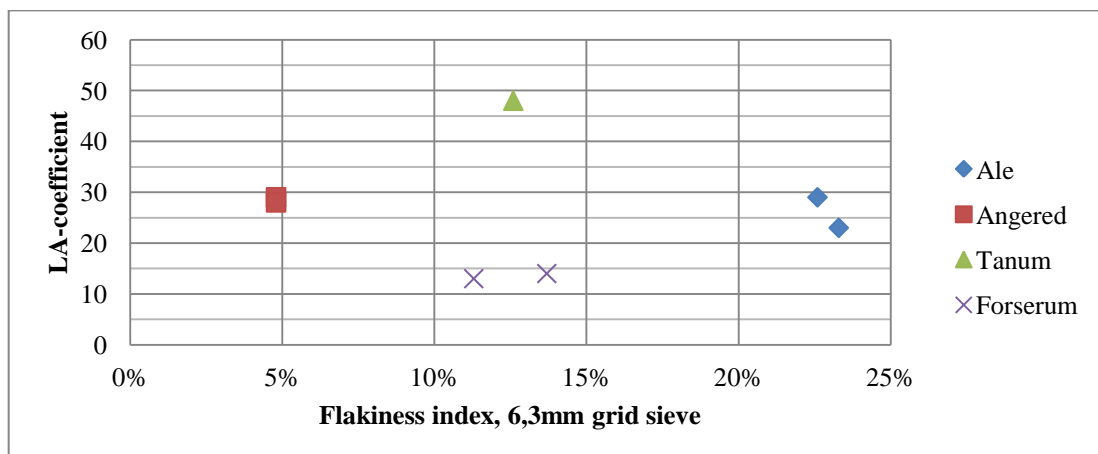
Figure G.3 Relation between LA-coefficient and flakiness index (6,3 mm grid sieve) for base course at all locations.

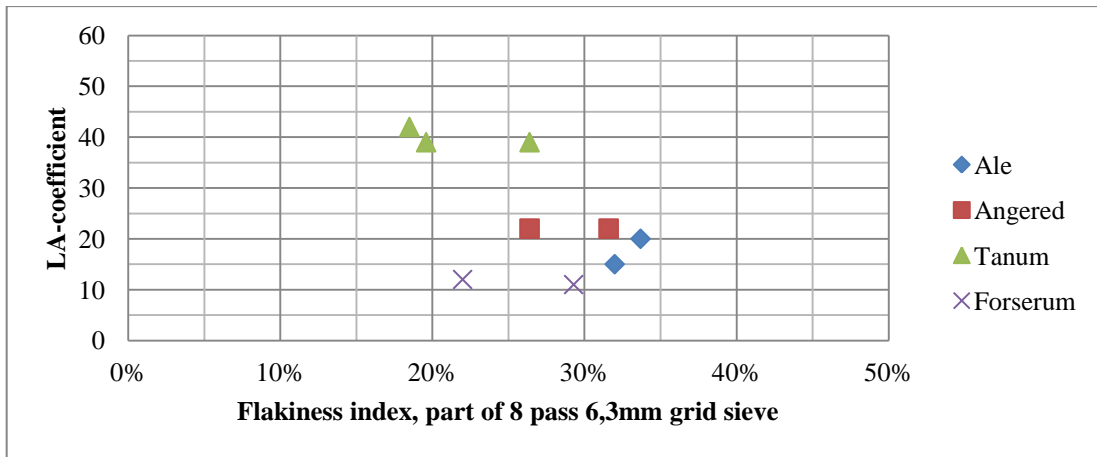
Figure G.4 Relation between LA-coefficient and flakiness index (part of 8 mm passing through 6,3 mm grid sieve) for rock cores at all locations.
